FAILURE MECHANISM OF CONCRETE SABO DAM BY ROCK IMPACT

Joji Shima¹, Ippei Takeda¹, Ryo Matsuzawa², Masuhiro Beppu³,
Nobutaka Ishikawa^{4*} and Takahisa Mizuyama⁵

Abstract. *This paper presents a computational approach on the failure mechanism of concrete sabo dam by rock impact. First, the site survey after a debris flow disaster was performed in order to investigate the failure mechanism of a concrete sabo dam and examine the size and velocity of rocks. Especially, it was observed that cracks occurred on the rear face of concrete sabo dam. Therefore, we assumed four scenarios of a rock impact onto a concrete dam. Case 1 is a small rock with a diameter of 1.1m and impact velocity of 7.01m/s onto the upper part of the dam, and Case 2 is a small rock onto the lower part of the dam. Case 3 is a large rock with a diameter of 6.7m and impact velocity of 9.7m/s onto the upper part of the dam, and Case 4 is a large rock onto the lower part of the dam. The impact analysis was conducted for four scenarios of a rock onto a concrete sabo dam by using the AUTODYN.*

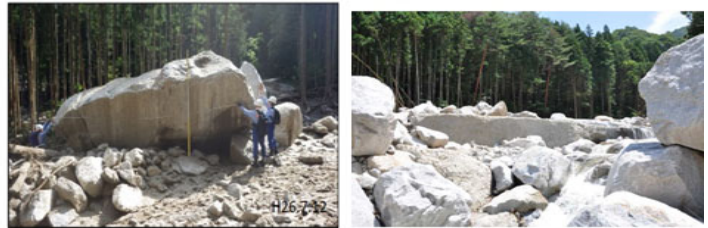
At the planning of dam construction, a design load was assumed as a rock diameter with 1.1m and flow velocity with 7.01m/sec by the field survey before the disaster. After the debris flow disasters, we surveyed the disaster site to investigate the failure mechanism of concrete sabo dams, the size and velocity of rocks. We discovered the cracks on the rear face of a concrete sabo dam with the width of about 10m, as shown in Figure 3. We also found out the largest rock with the diameter of 6.7m, as shown in Figure 4(a). However, the diameters of rocks at the site were almost 1m, as shown in Figure 4(b). The flow velocity of debris flow was estimated as 9.7 m/sec by measuring the peak flux of debris flow of 730m³/sec and computing based on the Manning formula.

(a)Largest rock diameter of 6.7m (b)Average rock diameter of 1m

Figure 4: Remaining rocks at the field survey

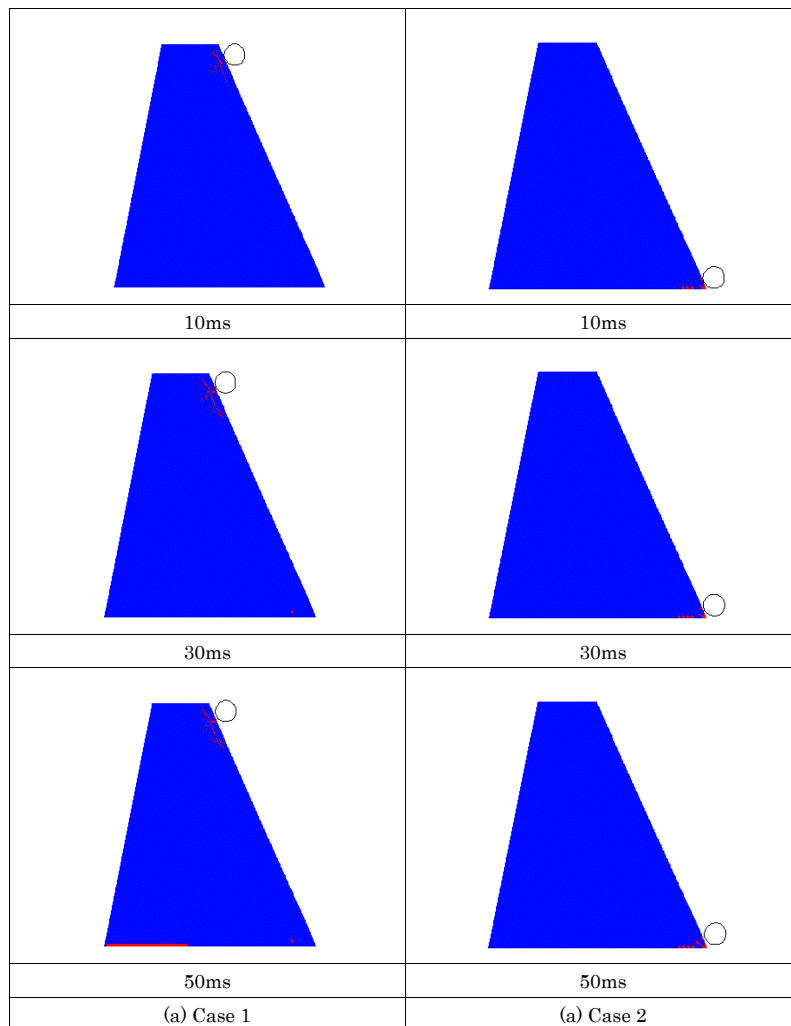
The failure process by computation of case1 was obtained as shown in Figure 7(a). At the time of 10ms, the cracks have occurred at the impact point, and then the shearing failure occurred partially at the back side of base. This may be caused by the dam vibration of the horizontal displacement –time realtion. Therefore, the failure of case 1 was only locally at the impact point and the bottom.

Figure 7: Failure mechanisms of Cases 1 and 2

At the time of 10ms, the cracks have occurred at the only impact point of the bottom, but the failure has not enlarged at the bottom of dam. Therefore, case 2 was locally failed at the only impact point of the bottom.

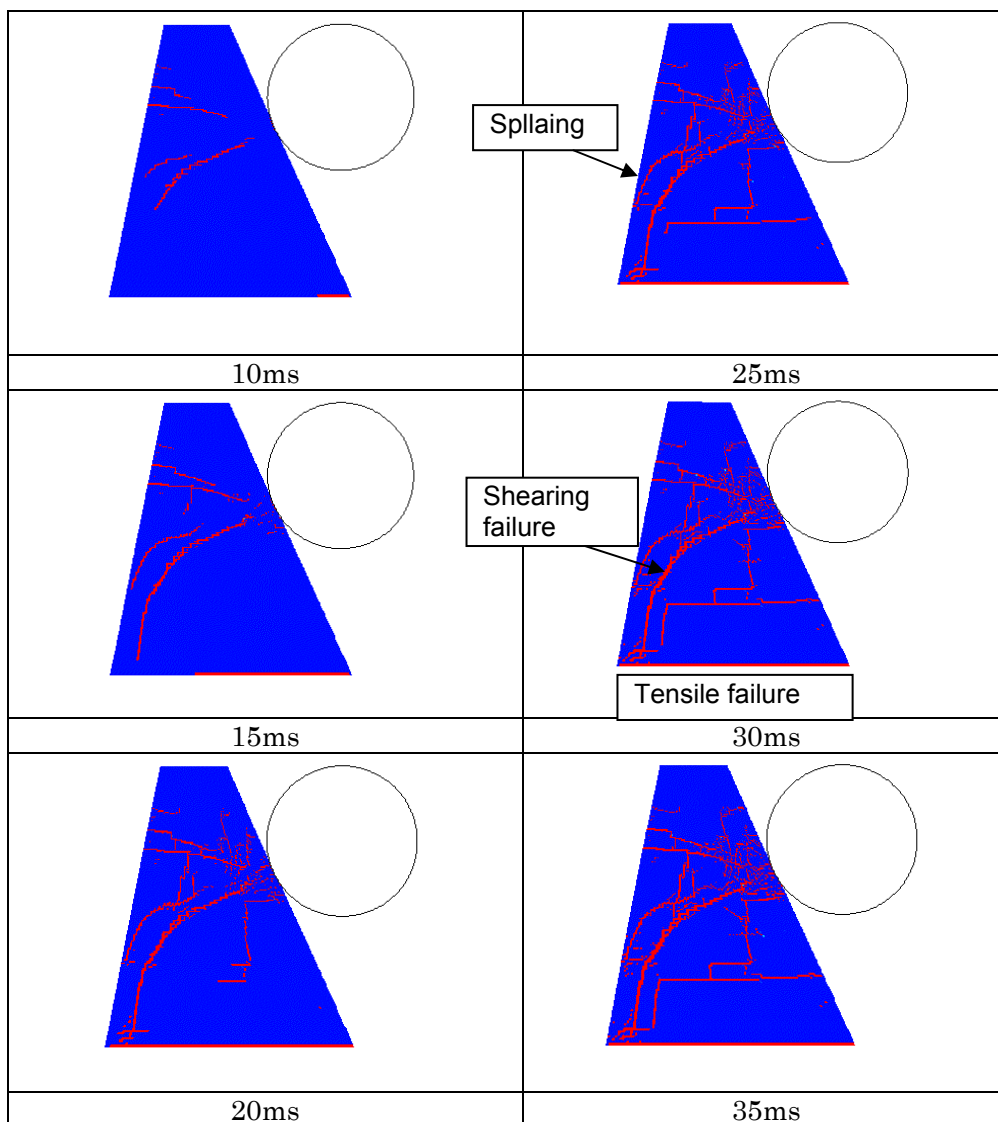
At the time of 10ms, the cracks have occurred at the impact point, and then tensile failure has extended at the front side of bottom of the dam at the time of 15ms, and then, the shearing failure occurred from the impact point to the back end of the bottom at the time of 20-25ms. The compressive wave has propagated to the rear face and then, reflected to the front direction. This is called as a spalling phenomenon occurred at the rear face. Consequently, the failure mechanism of case 3 was widely occurred by the shearing and tensile failures at the same time. Especially, the cracks at the rear face of the dam as shown in Figure 3 may be caused by the spalling phenomenon at case 3.

Figure 12: Failure mechanism of Case3

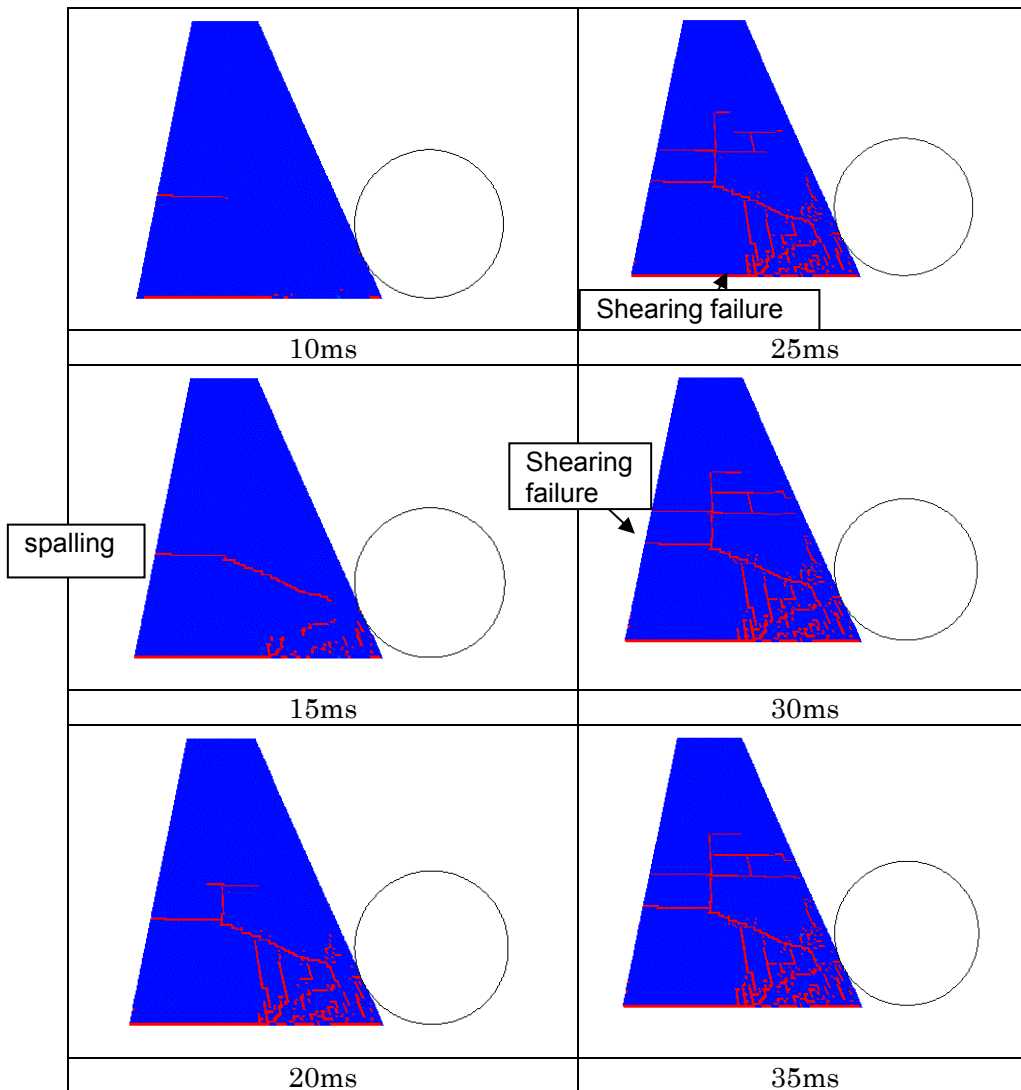
The failure mechanism of case 4 was obtained, as shown in Figure 15. At the time of 10ms, the compressive wave has propagated to the rear face and then, reflected to the front direction. Therefore, the cracks occurred at the rear face due to spalling effect of wave propagation. The shearing failure has started at the back side of bottom of the dam at the time of 10-15ms. The another shearing failure has extended from the impact point to the rear face of the dam, at the same time of 20-25ms. Consequently, the failure mechanism of case 4 was widely occurred by the two shearing failures at the bottom and the main body simultaneously. Especially, the cracks at the rear face of the dam as shown in Figure 3 may be also considered by the spalling phenomenon at case 4.

Figure 15: Failure mechanism of Case 4
