DAMAGE OF STEEL OPEN SABO DAMS BY ROCK IMPACT

Abstract. *There have been recent damaged examples of steel open-type Sabo dams (hereafter, steel open dams) which illustrate protective structures against debris flow. This was caused due to large rocks carried in the debris flow resulted from torrential rainfall of abnormal weather. This paper presents a computational approach to investigate the damage of a steel open dam by a fluid load and rock impact in the debris flow. First, the field survey after disaster was performed in order to examine the damage of steel open dams and the remaining rocks. Second, the impact FEM analysis of a steel open dam against a large fluid load and huge rocks was conducted by using the software of ANSYS AUTODYN.*

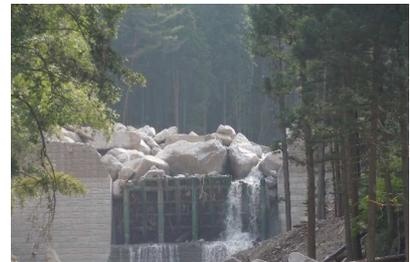
Figure 1: Steel open dam trapped rocks in debris flow

Figure 1 illustrates an actual trapping case of a steel open dam against abnormally large rocks (diameters greater than 3m). Figure 2 shows a further example in which the upper part of the dam experienced partial collapse, although this dam was able to trap large rocks.

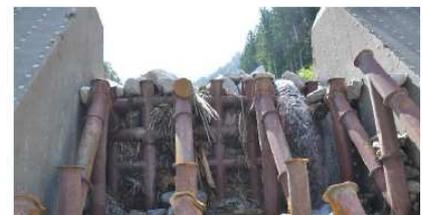
In order to prevent debris flow and sediment-related disasters, many steel open dams have been constructed in Japan, as shown in Figure 1. However, a steel open dam has partially collapsed due to rocks in the debris flow, as shown in Figure 2. These disasters may have resulted due to torrential downpour as a result of unusual weather conditions [1, 2].

Figure 2: Steel open dam was partially collapsed by large rocks

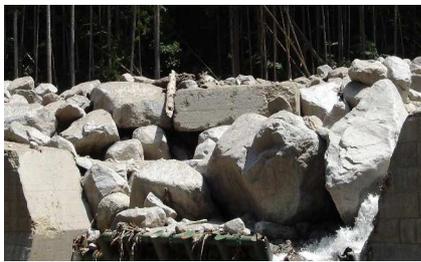
Figure 3 shows many rocks found downstream after debris flow at Nagiso. Figure 4 illustrates the largest rock with a width of 10m and a long of 3.5m and, therefore, an average diameter of 6.7m. Therefore, it is necessary to locate abnormally large rocks in the field survey prior to the design process, as shown in Figure 5.

Figure 3: Rocks found at downstream

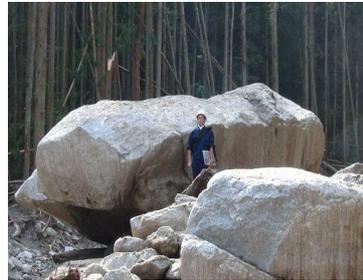
Figure 4: The largest rock with diameter of 6.7m

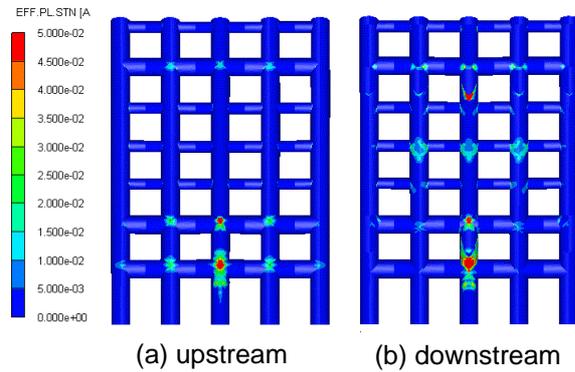
The computational result shows that the steel open dam was only damaged due to flexural action in which the palstic strains occurred at the upstream and downstream, as shown in Figure 9. Figure10 (a) shows the final deformation profiles which was not so damaged at $F=583.5kN/m$ which was the stable limit load of structure, but Figure10 (b) illustrates the severely deformation profile at $F=722.9kN/m$ which was the ultimate deformable limit load of the structure. Therefore, it was confirmed that this steel open dam can resist until the ultimate deformable limit fluid load of 722.9 kN/m. Figure 11 represents the pipe reaction-time relation responded by fluid load of $F=583.5kN/m$. It

Figure 9: Plastic strains by fluid load of $F=583.5\text{kN/m}$

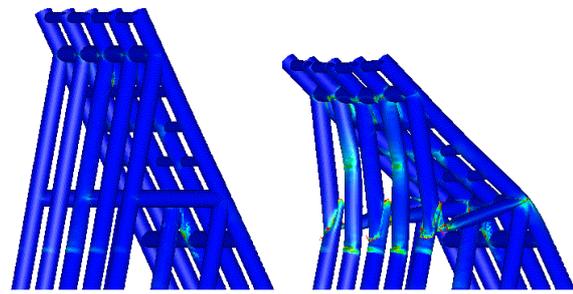
Figure10: Final deformations by fluid loads

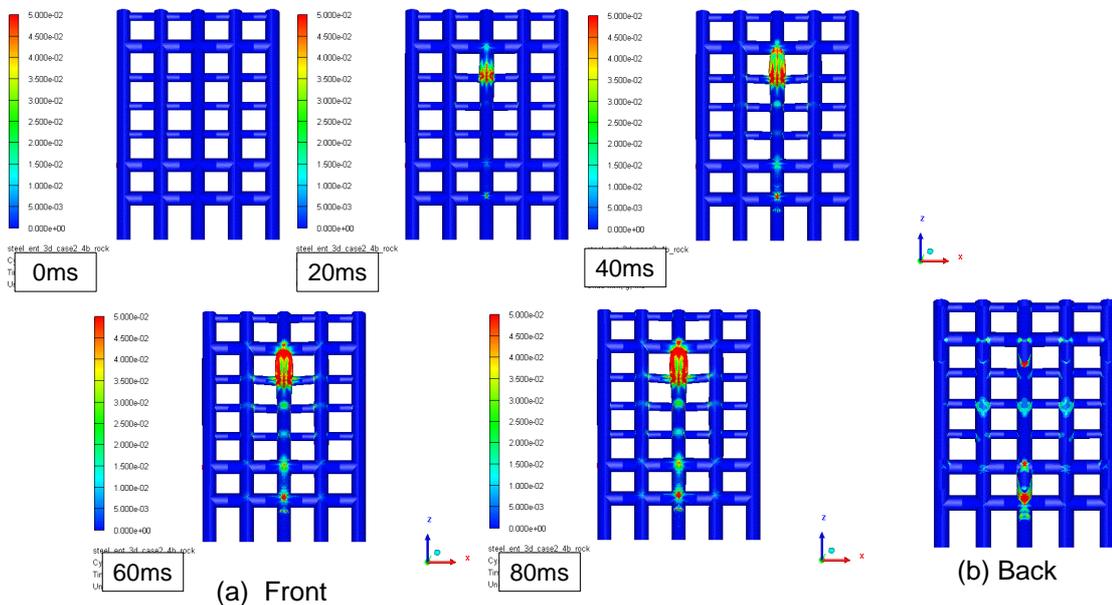
Figure 14 (a) shows the damage process of the front of the steel open dam against Case 1. It was found that large plastic strains were only limited at the impact point. Figure 14 (b) is the damage of the back side of the dam in which the plastic strains were occurred at the joints between diagonal members and columns.

Figure 14: Damage process (front and back) of steel open dam against Case 1

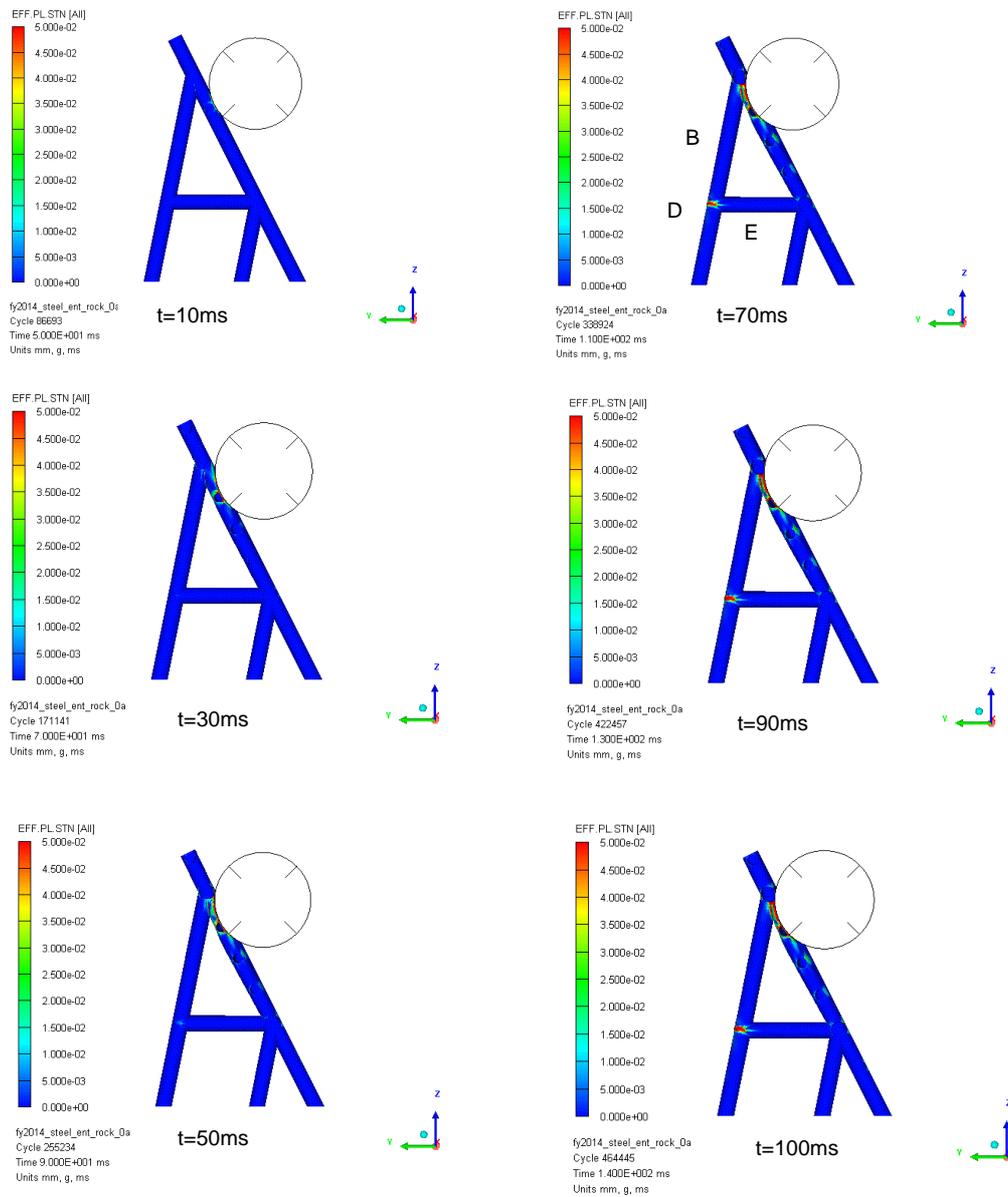
Figure 15 illustrates the damage process of the side of the steel open dam against Case 1. It was recognized that the damage was only limited at the impact point at the time $t=30-50\text{ms}$, but it propagated to the joint D between the diagonal member B and cross beam E at the time 70-100ms. The maximum plastic strain (0.05 (5%)) has occurred at the impact point and the joint D at the time 70-100ms.

Figure 15: Damage process (side) of steel open dam against Case 1

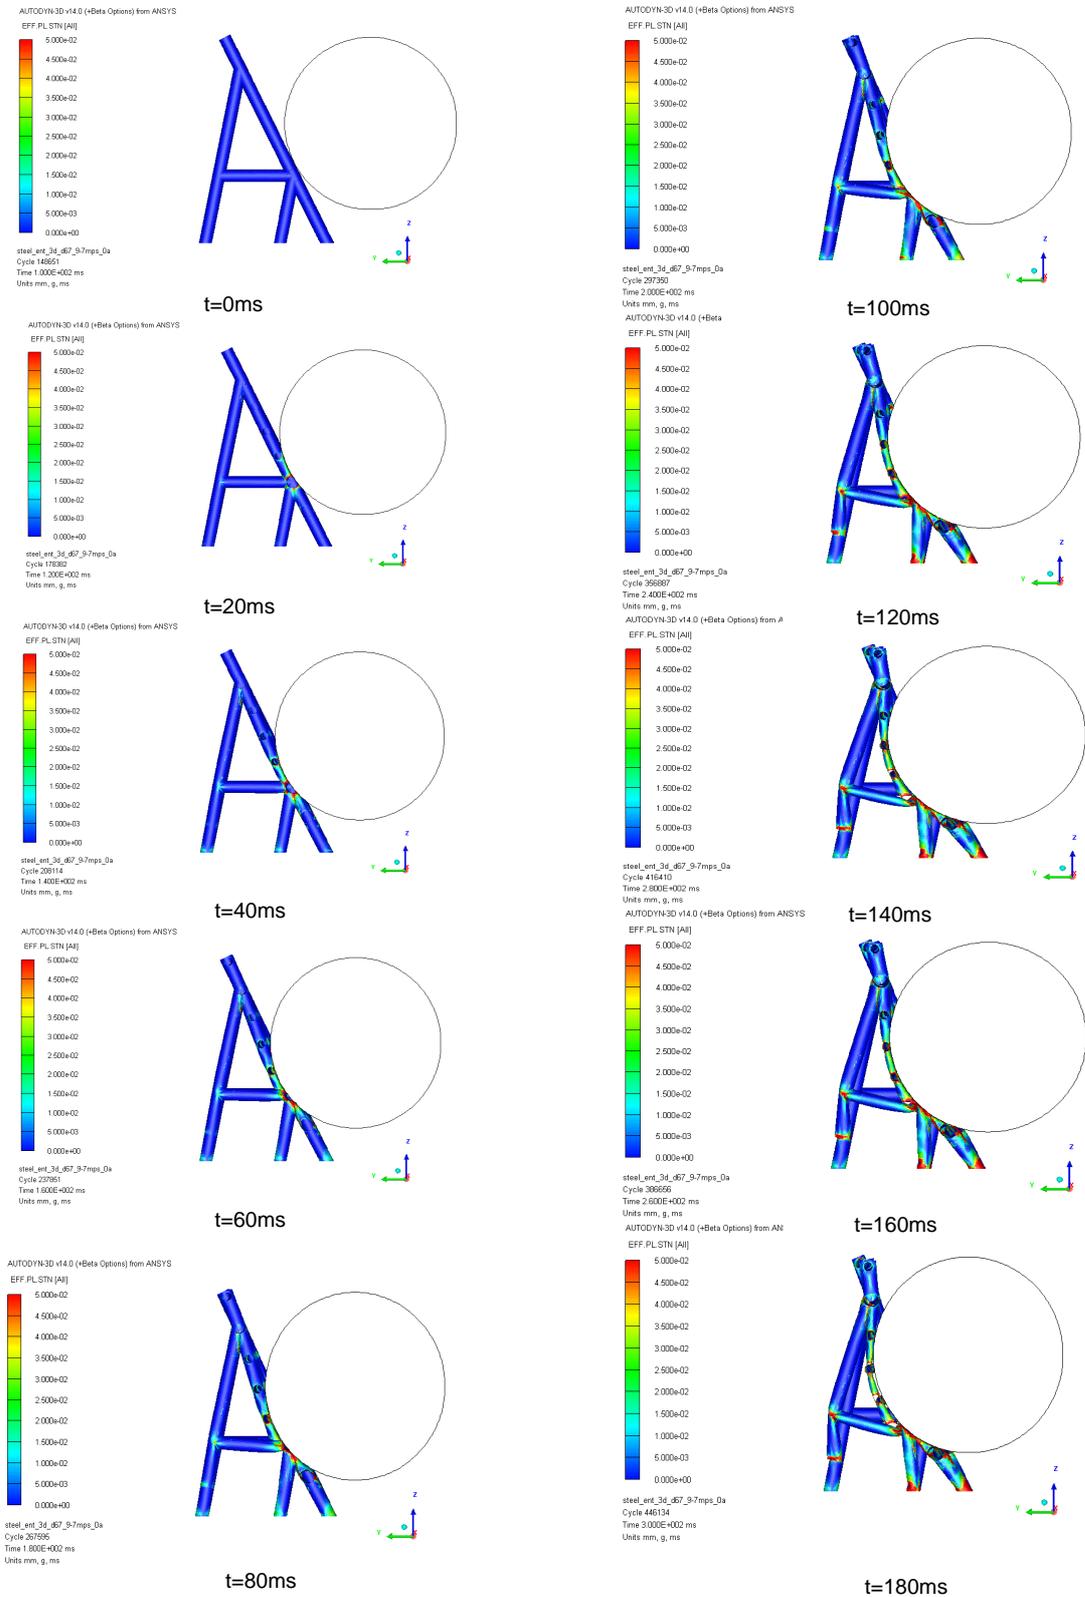
with diameter of 6.7m and velocity of 9.7m/s, which were measured by the site field survey. Figure 17 shows the deformation process (side) of the steel open dam against Case 2. The structure was not completely collapsed against Case 2, although the large deformations occurred at the time 120-180ms.

Figure 17: Deformation process (side) of steel open dam against Case 2

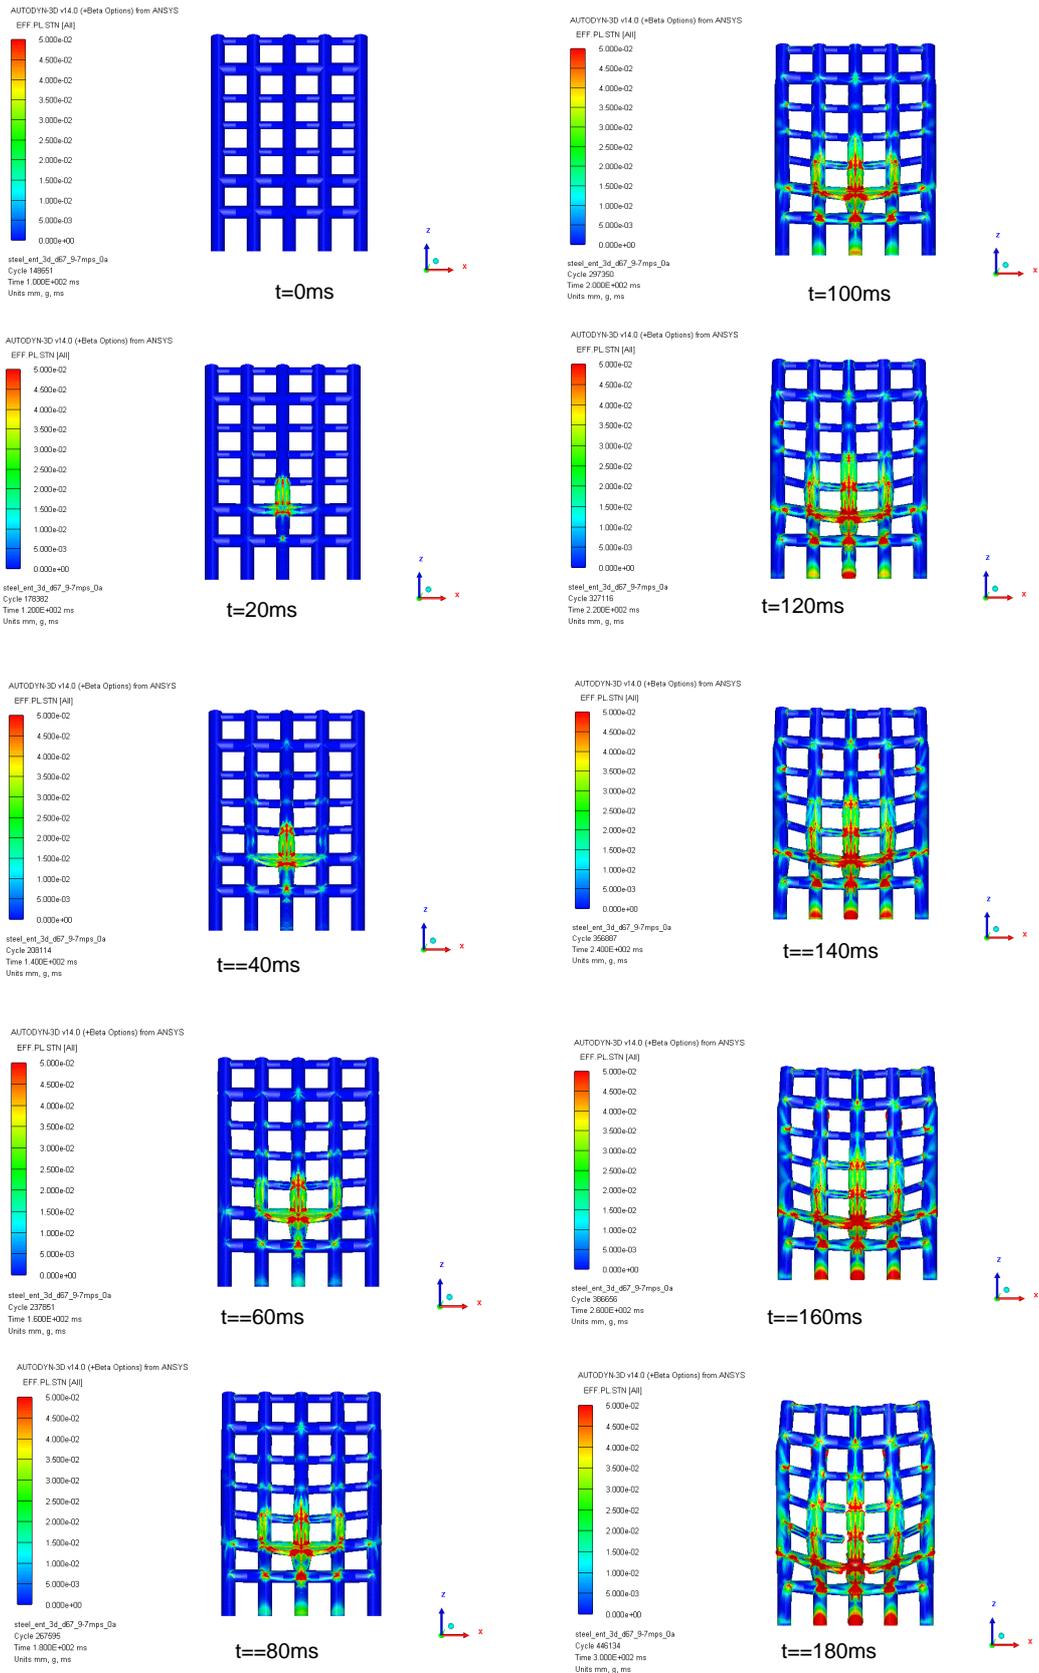
Figure 18: Damage process (front) of steel open dam against Case 2

Figure 18 shows the damage process (front) of steel open dam against a rock impact of Case 2. It

was found that the first plastic strain occurred at the joint between front column and diagonal members at the time $t=20-40\text{ms}$, and it propagates to the rear diagonal member through the cross beam at the time $t=60-80\text{ms}$. It was also recognized that the impacting rock energy was absorbed by the global deformation of the dam as well as the local deformation of a pipe at the time $t=120\text{ms}-200\text{ms}$, as shown in Figure 18 (d)-(f).

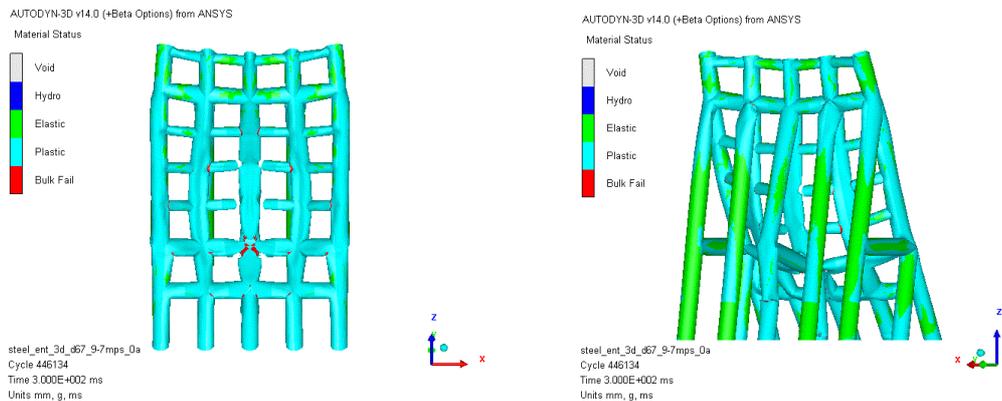
Figure 19 (a) and (b) represent the final deformation profiles at the front view from upstream and the diagonal view from downstream against Case 2, respectively. It was judged that the joint between the center column and the diagonal member was severely damaged, as shown in Figure 19 (a) and the global buckling occurred at the diagonal member of the center, as shown in Figure 19 (b).

(a) Front view from upstream (b) Diagonal view from downstream
Figure 19: Final deformation profile by rock impact of Case 2

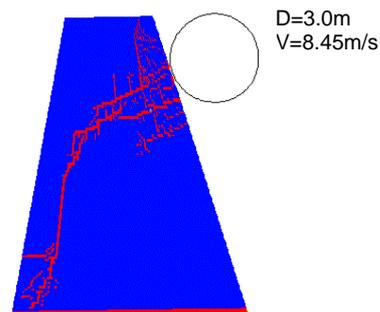
The concrete dam as shown in Figure 20 was analyzed [9] against the same rock impact condition of Case 1 to compare with the steel open dam. Figure 21 shows the computational result of concrete dam against rock impact of Case 1 [9]. It was found that the shearing failure and the tensile failure occurred at the whole body and at the bottom, respectively, as shown in Figure 21. Therefore, the concrete dam was completely collapsed and overturned, while the steel open dam was only damaged at the impact points, as shown in Figures 14 and 15.

Figure 21: Collapse mode of concrete dam against Case 1
