FAILURE MECHANISM OF CONCRETE SABO DAM BY ROCK IMPACT

Joji Shima¹, Ippei Takeda¹, Ryo Matsuzawa², Masuhiro Beppu³,
Nobutaka Ishikawa^{4*} and Takahisa Mizuyama⁵

Abstract. *This paper presents a computational approach on the failure mechanism of concrete sabo dam by rock impact. First, the site survey after a debris flow disaster was performed in order to investigate the failure mechanism of a concrete sabo dam and examine the size and velocity of rocks. Especially, it was observed that cracks occurred on the rear face of concrete sabo dam. Therefore, we assumed four scenarios of a rock impact onto a concrete dam. Case 1 is a small rock with a diameter of 1.1m and impact velocity of 7.01m/s onto the upper part of the dam, and Case 2 is a small rock onto the lower part of the dam. Case 3 is a large rock with a diameter of 6.7m and impact velocity of 9.7m/s onto the upper part of the dam, and Case 4 is a large rock onto the lower part of the dam. The impact analysis was conducted for four scenarios of a rock onto a concrete sabo dam by using the AUTODYN.*

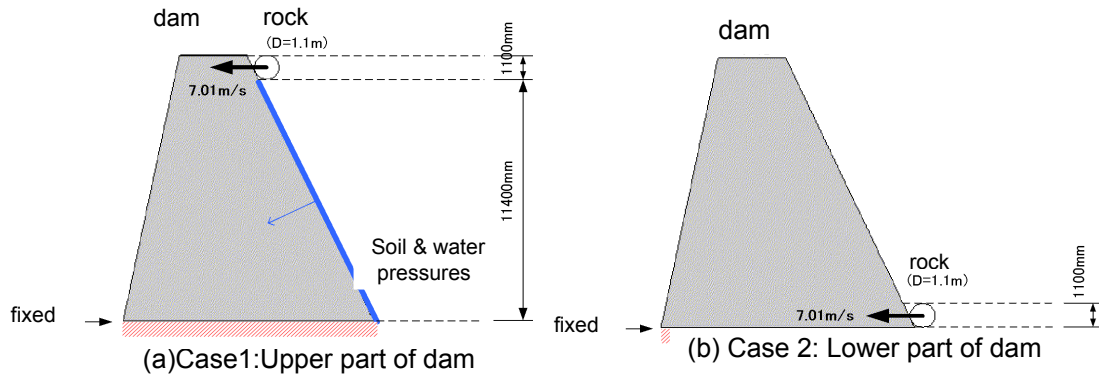
Figure 6: A small rock impact onto the dam

A small rock with diameter of 1.1m and velocity of 7.01m/sec hit on the upper part of concrete dam after acting of the soil and water pressures as shown in Figure 6(a).

A small rock with diameter of 1.1m and velocity of 7.01m/sec hit on the lower part of the dam without soil and water pressures, as shown in Figure 6(b).

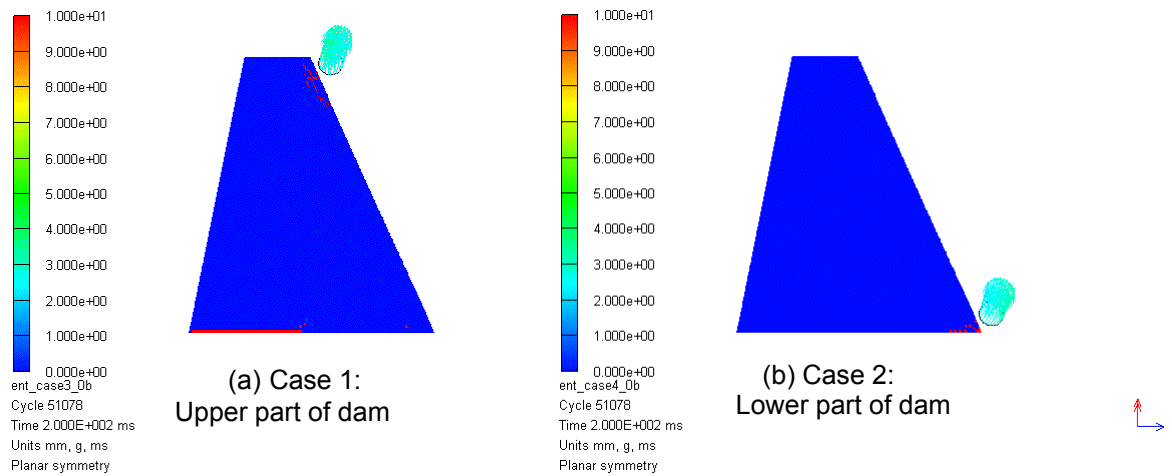
Figure 9: A small rock impact velocity distributions

Figure 9(a) shows a velocity distribution of a small rock onto the upper part of the dam at the time of 50ms. It was found that a rock jumped up to the top of dam and dropped down to the opposite side of impact direction.

Figure 9(b) illustrates the impact velocity – time relation of a small rock onto the lower part of the dam. It was recognized that the horizontal direction of impact velocity was suddenly decreased from 7.01m/sec at 0ms to -0.4m/s at 3ms which means the opposite direction of impact. On the other hand, the vertical direction of impact velocity was increased to 3.7m/sec at 3ms and decreased to 2.7m/sec at 100ms due to the gravity effect. Therefore, the absolute velocity became the same one as the vertical direction after the time of 3ms.

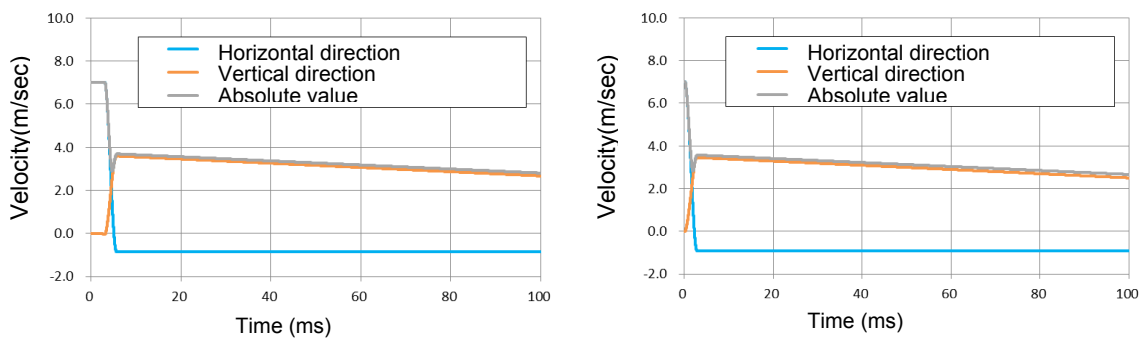
Figure 10: Rock velocity-time relation of a small rock

Figure 10(a) illustrates the relationship between impact velocity and time against a small rock. It was confirmed that the horizontal direction of impact velocity was suddenly decreased from 7.01m/sec at 0ms to -0.5m/s at 5ms which means the opposite direction of impact. On the other hand, the vertical direction of impact velocity was increased to 3.8m/sec at 6ms, but decreased to 3.0m/sec at 100ms due to the gravity effect. Therefore, the absolute velocity became the same one as vertical direction after the time of 6ms.

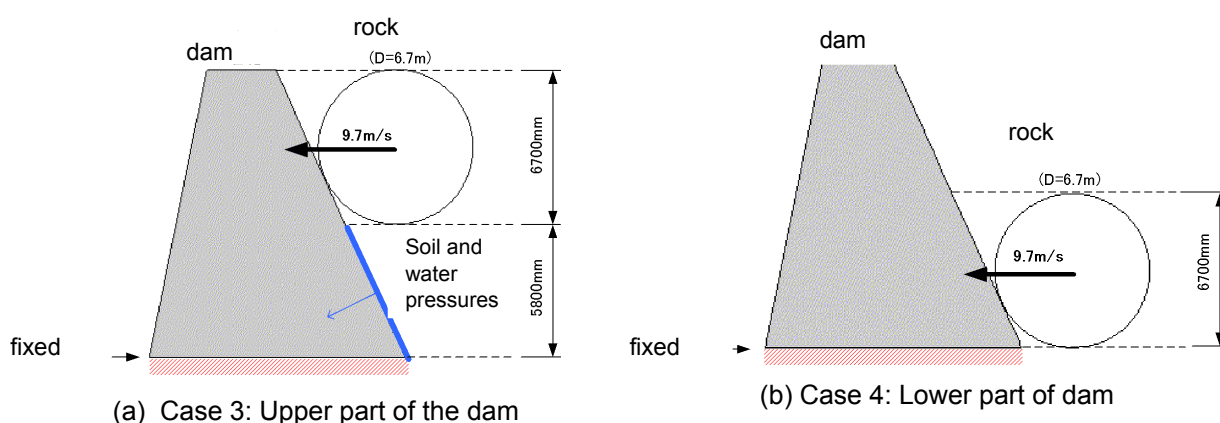
Figure 11: A large rock impact onto the dam

A large rock with diameter of 6.7m and velocity of 9.7m/sec hit on the upper part of concrete sabo dam after acting of the soil and water pressures, as shown in Figure 11 (a).

A large rock with diameter of 6.7m and velocity of 9.7m/sec hit on the lower part of concrete dam as shown in Figure 11 (b).

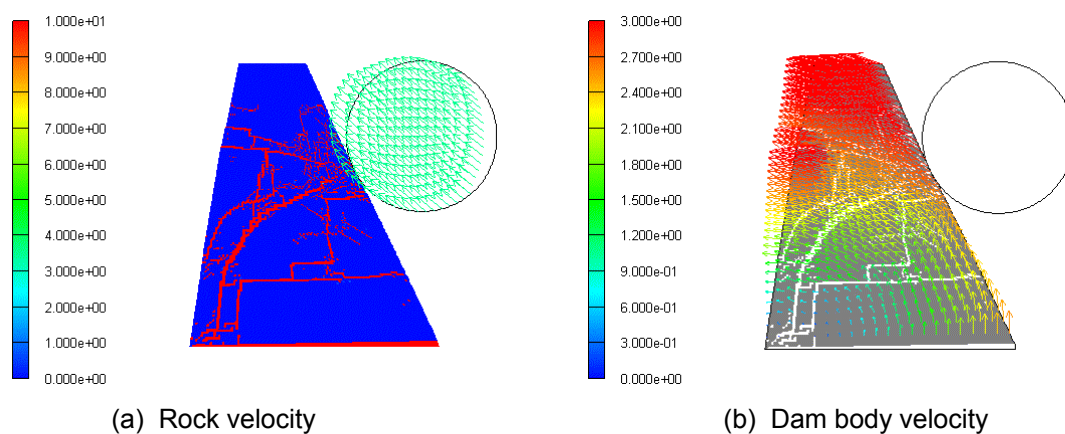
Figure 13: Rock and dam body velocities of Case 3

Figure 13(a) and (b) show the rock and dam body velocity distributions against a large rock impact onto the upper part of the dam at the time of 50ms, respectively. It was found that a rock jumped up to the top of dam and fell to the opposite side of impact direction. It was also observed that dam body vibrates widely to the downstream. Then, it was confirmed that the dam body rotated about the back end of the base and tended to overturn to the downstream.

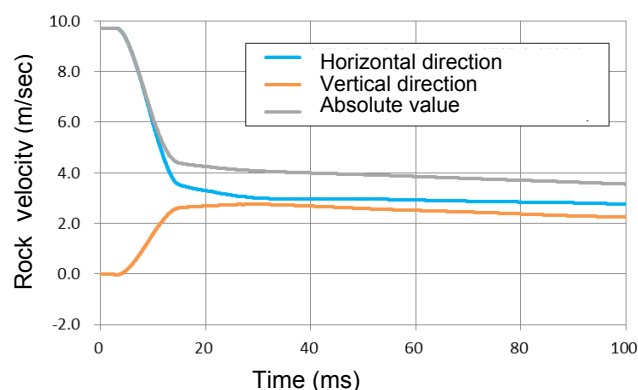
Figure 14: Rock velocity-time relation of Case 3

Figure 14 illustrates the rock velocity – time relation of a large rock impact onto the upper part of the dam (case 3). It was recognized that the horizontal direction of impact velocity 9.7m/s was suddenly decreased to 3.7m/s at 13ms, and became 3.0m/s at 100ms.

On the other hand, the vertical direction of impact velocity increased to 2.5m/sec at 15ms, but decreased to 2.2m/sec at 100ms due to the gravity effect. Therefore, the absolute velocity became 4.0m/sec after the time of 20ms. Consequently, the remaining rock velocity became constant of about 4.0m/sec, and therefore, it was confirmed that the dam body would tend to overturn to the downstream due to the tensile failure at the base and the diagonal shearing failure of main body.

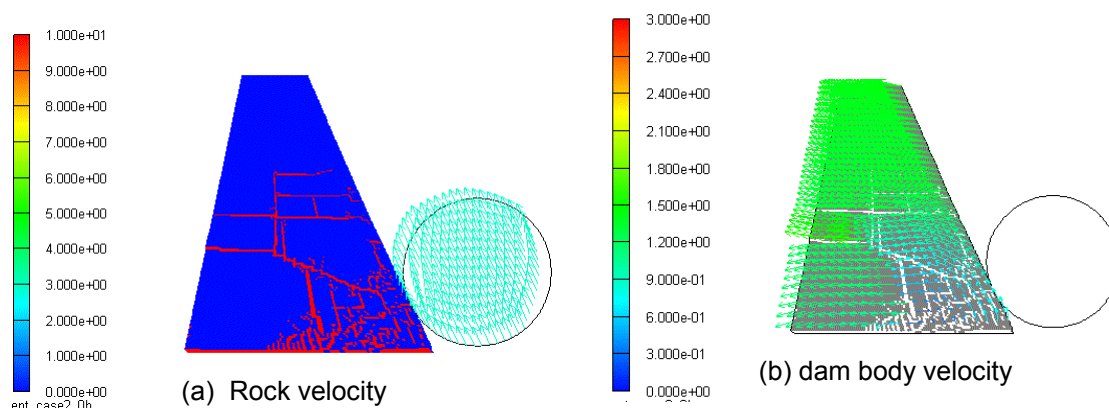
Figure 16: Rock and dam body velocities of Case 4

Figure 16(a) and (b) show the rock and dam body velocity distributions against a large rock impact onto the lower part of the dam at the time of 50ms, respectively. It was found that a rock jumped up to the upper direction and fell to the opposite side of impact direction. It was also observed that dam body has widely moved to the direction of downstream.

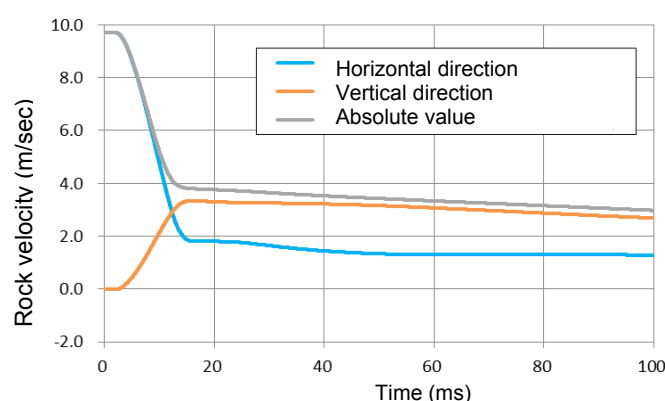
Figure 17: Rock velocity-time relation of Case 4

Figure 17 illustrates the rock velocity – time relation of Case 4 that a large rock impact onto the lower part of the dam. It was recognized that the horizontal direction of impact velocity 9.7m/s was suddenly decreased to 2m/s at 15ms, and became 1.2m/s at 100ms. On the other hand, the vertical direction of impact velocity increased to 3.5m/sec at 15ms, but decreased to 2.5m/sec at 100ms due to the gravity effect. However, the absolute velocity of rock was 4.0m/s at the time of 15ms and became 3.0m/s at 100ms.
