DAMAGE OF STEEL OPEN SABO DAMS BY ROCK IMPACT

Abstract. *There have been recent damaged examples of steel open-type Sabo dams (hereafter, steel open dams) which illustrate protective structures against debris flow. This was caused due to large rocks carried in the debris flow resulted from torrential rainfall of abnormal weather. This paper presents a computational approach to investigate the damage of a steel open dam by a fluid load and rock impact in the debris flow. First, the field survey after disaster was performed in order to examine the damage of steel open dams and the remaining rocks. Second, the impact FEM analysis of a steel open dam against a large fluid load and huge rocks was conducted by using the software of ANSYS AUTODYN.*

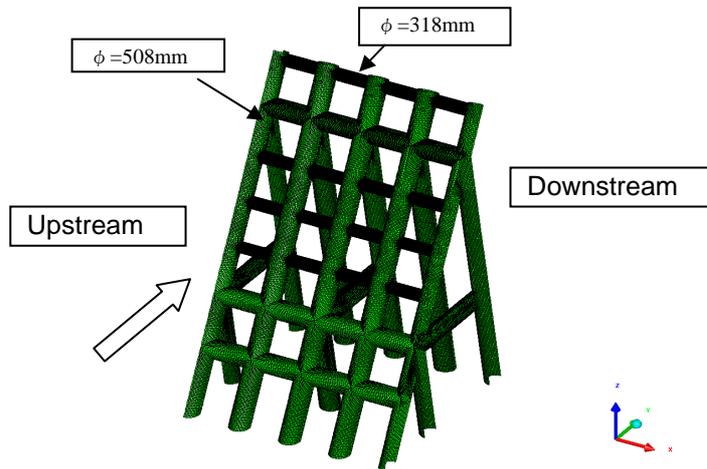
Figure 6: Steel open dam model (3-dimennsion)

Following this, it is necessary to conduct an impact FEM analysis against the large fluid load and huge rocks in order to confirm the integrity of a steel open dam, as shown in Figure 6. A steel open dam model with the height of 8m and the width of 5.2m which was connected by the joints between the thick pipe of 508mm with the thin pipe 318mm or joints between thick pipes is shown in Figures 6 and 7. The properties of steel pipe are the density of $7.85t/m^3$, Young's modulus of 206GPa, Poisson's ratio of 0.3, yield stress of 315Mpa and tensile strength of 593Mpa. The foots of pipes were fixed into the footing. Pipe diameter and thickness were modeled as shell elements.

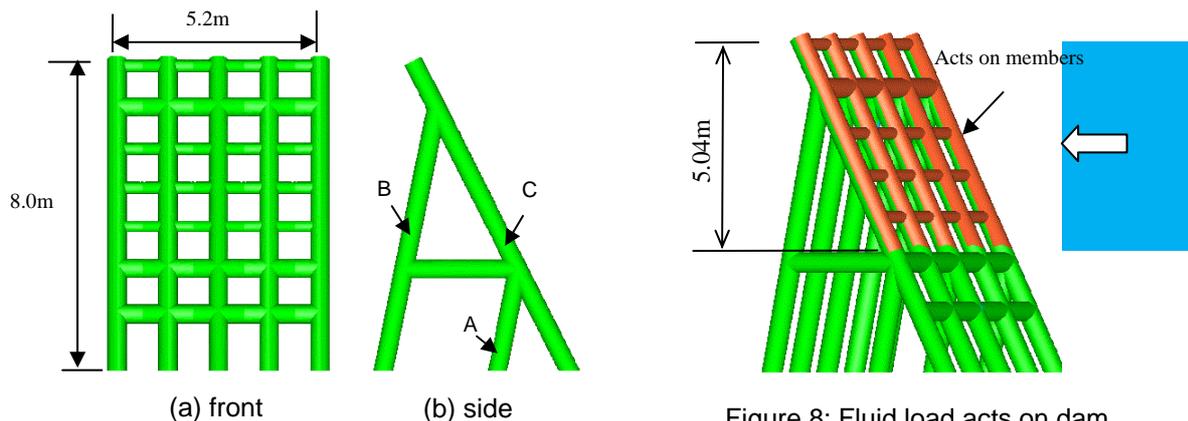
Figure 8: Fluid load acts on dam

A FEM impact analysis was conducted using the software of ANSYS AUTODYN [14,15] to examine the impact response against large fluid load $F=583.5kN/m$ with velocity of 8.45m/s which was found by the extreme conditions of the stable analysis, as shown in Figure 8.

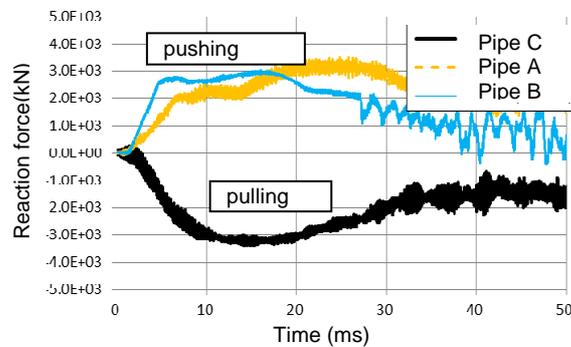
Figure11: Reaction force-time relation by fluid load

The computational result shows that the steel open dam was only damaged due to flexural action in which the palstic strains occurred at the upstream and downstream, as shown in Figure 9. Figure10 (a) shows the final deformation profiles which was not so damaged at $F=583.5kN/m$ which was the stable limit load of structure, but Figure10 (b) illustrates the severely deformation profile at $F=722.9kN/m$ which was the ultimate deformable limit load of the structure. Therefore, it was confirmed that this steel open dam can resist until the ultimate deformable limit fluid load of 722.9 kN/m. Figure 11 represents the pipe reaction-time relation responded by fluid load of $F=583.5kN/m$. It

was found that the reactions of pipes A and B were pushed, but the pipe C was pulled at about 3000kN, respectively. Therefore, it should be noted that the footing strength has to be resisted more than 3000kN.

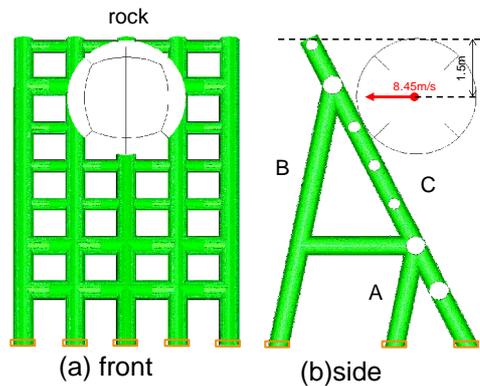
Figure 12: Rock impact of Case 1

Figure 12 shows a case 1 in which a steel open dam is struck by a rock with a diameter of 3.0m

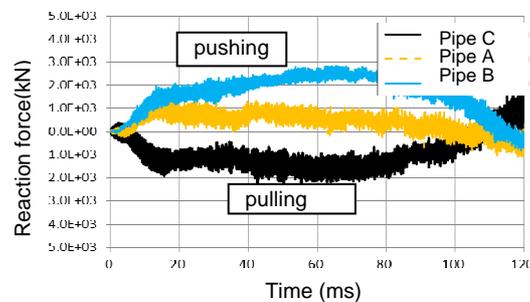
Figure 16: Reaction force-time relation of Case 1

Figure 16 shows the relationship between reaction of pipe and time by a rock impact of Case 1. It is interested to note that the reaction of pipe A (1000kN) was smaller the one of fluid load (3000kN), because the impacting rock energy was only absorbed by the local deformation of the pipe at the

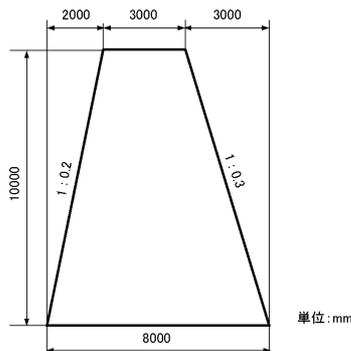
Figure 20: Concrete dam model

The concrete dam as shown in Figure 20 was analyzed [9] against the same rock impact condition of Case 1 to compare with the steel open dam. Figure 21 shows the computational result of concrete dam against rock impact of Case 1 [9]. It was found that the shearing failure and the tensile failure occurred at the whole body and at the bottom, respectively, as shown in Figure 21. Therefore, the concrete dam was completely collapsed and overturned, while the steel open dam was only damaged at the impact points, as shown in Figures 14 and 15.
